Manhole Inspection Summary

Manhole # S15II_015MH

Insp Date: **10/26/07 11:33 AM**

Location Address: **REAR 1737 ASHBURTON**

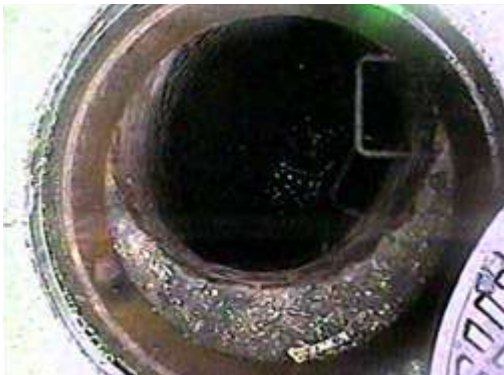
Top View

Offset: **6** (in.)

Frame offset

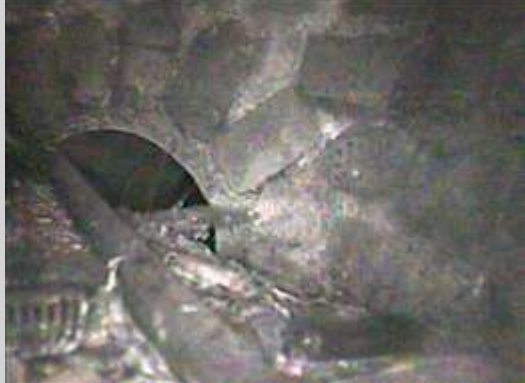
12 O'Clock Outflow

8 in. Circular Gravity Sewer
Pipe Out @ 12 O'Clock

Deposits: ☐ None ☐ Mud ☐ Sludge ☒ **Debris** ☐ Grease

Silt Depth: **3** (in.) Deposits Extent: **Medium**
